Emergency Watershed Protection (EWP) Program Utah

***Santa Clara River – Washington County
December 2010***

***Norm Evenstad
Water Resources Coordinator
USDA-NRCS, Salt Lake City, Utah***

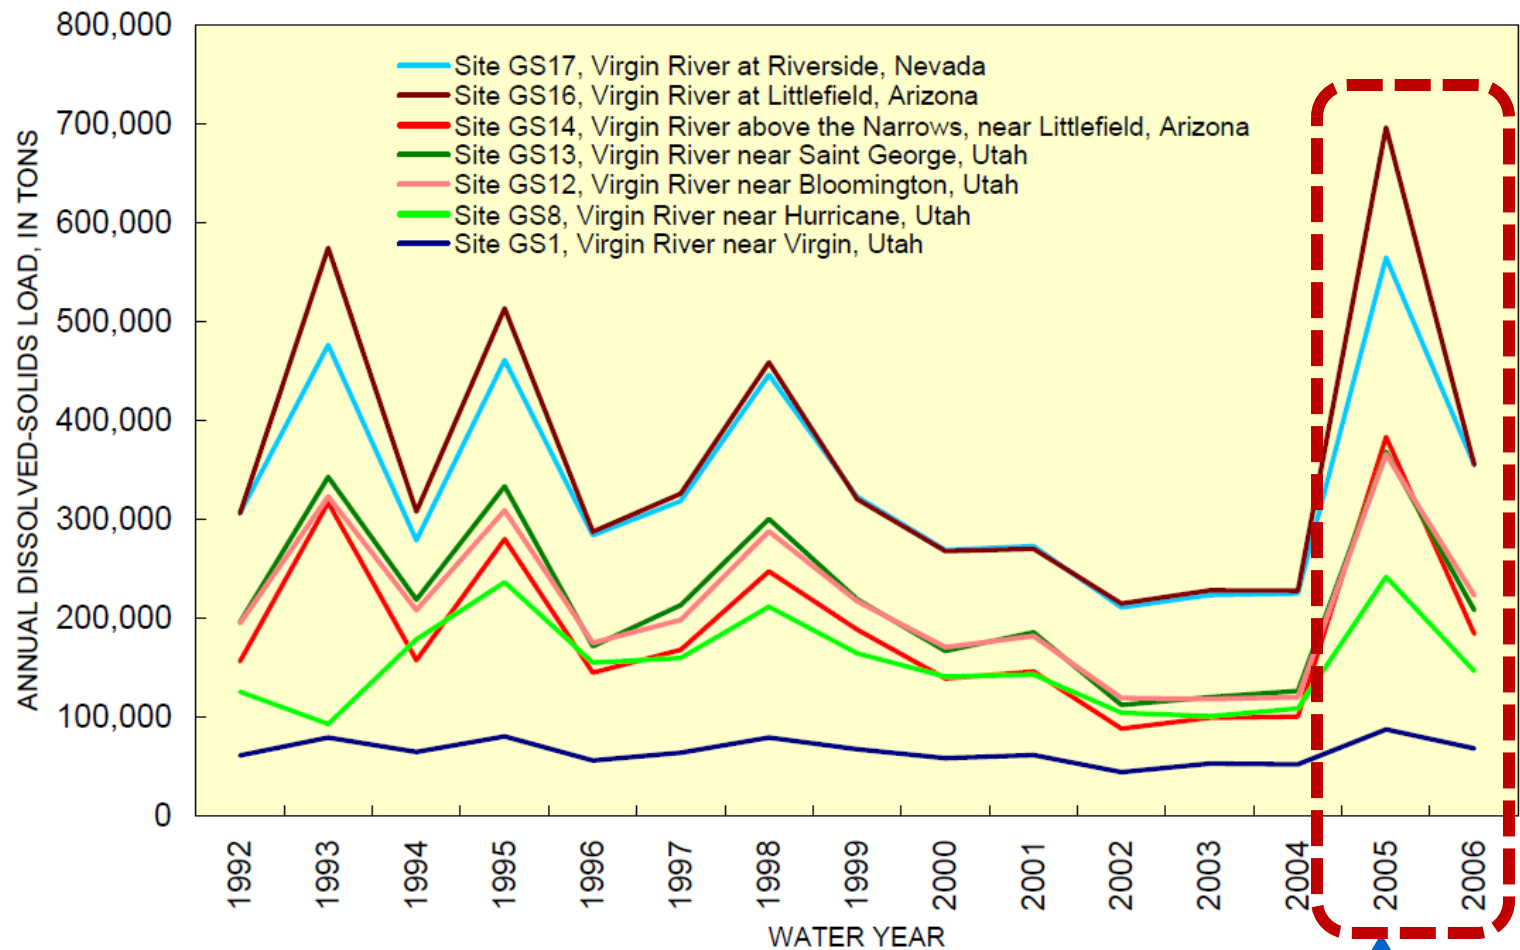
Figure 5. Annual dissolved-solids loads at selected sites in the Virgin River Basin, 1992-2006.

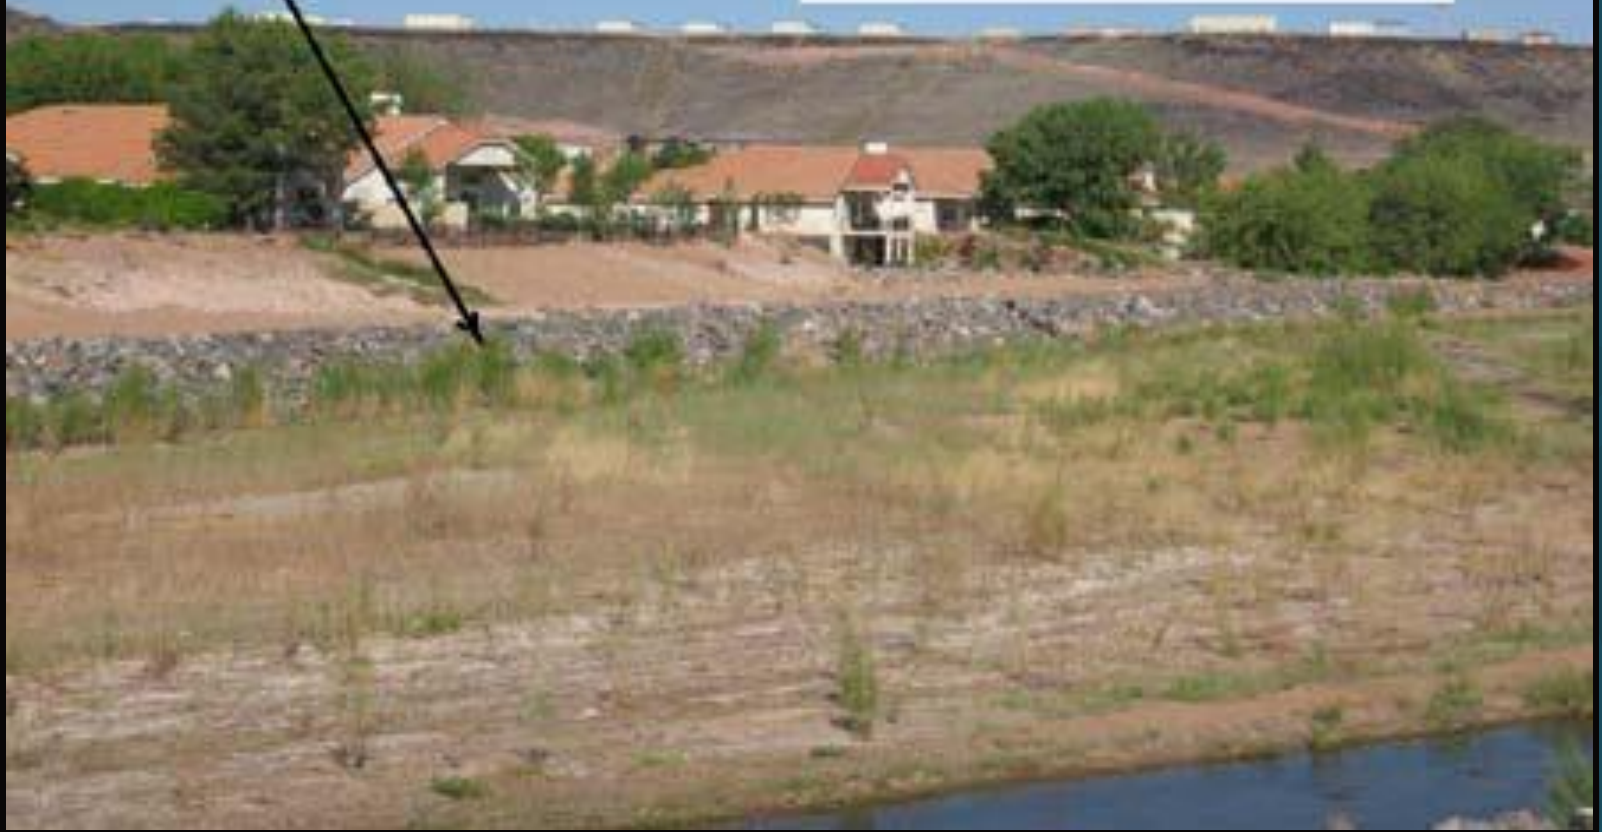
Lower Santa Clara - 2006

Note Veg re-establishment

Utah: Washington County EWP
Lower Santa Clara River
Area where house fell into river

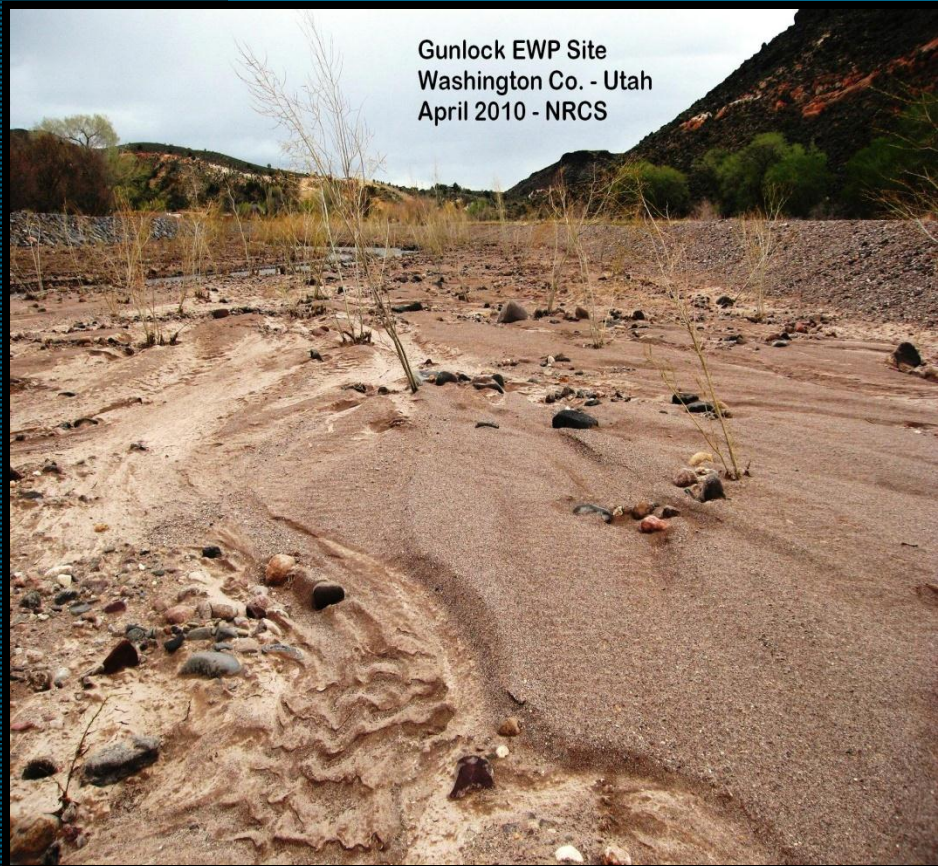
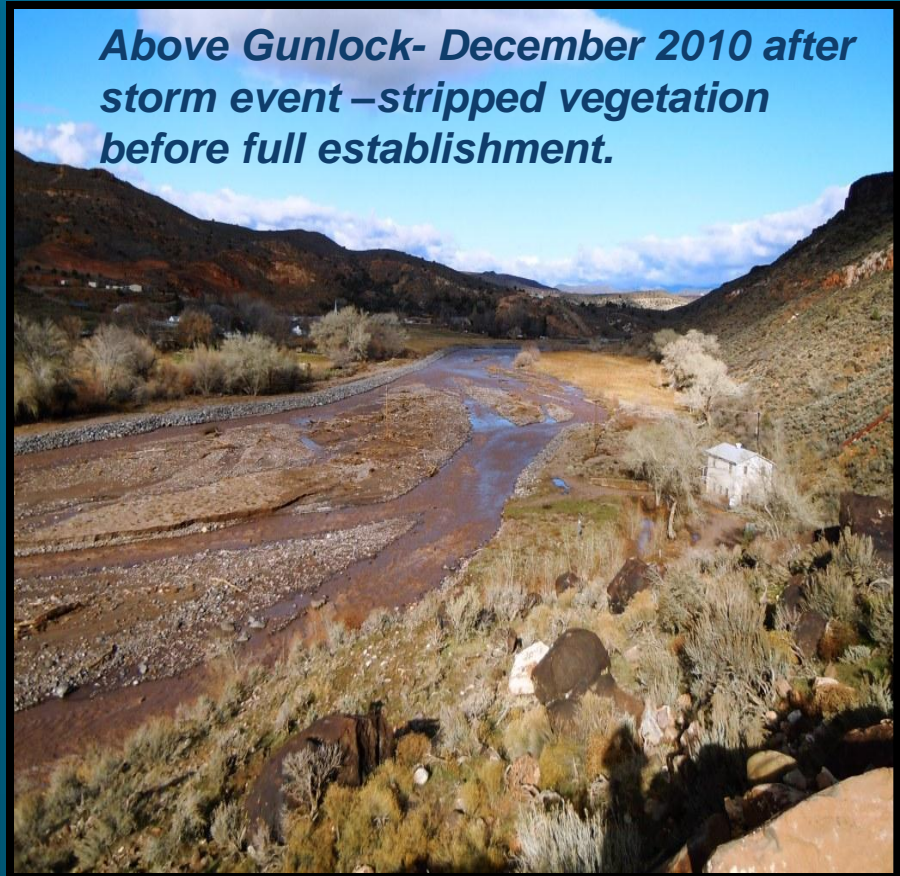
UPPER SANTA CLARA

Geomorphic approach, meander design, plantings, j-hooks

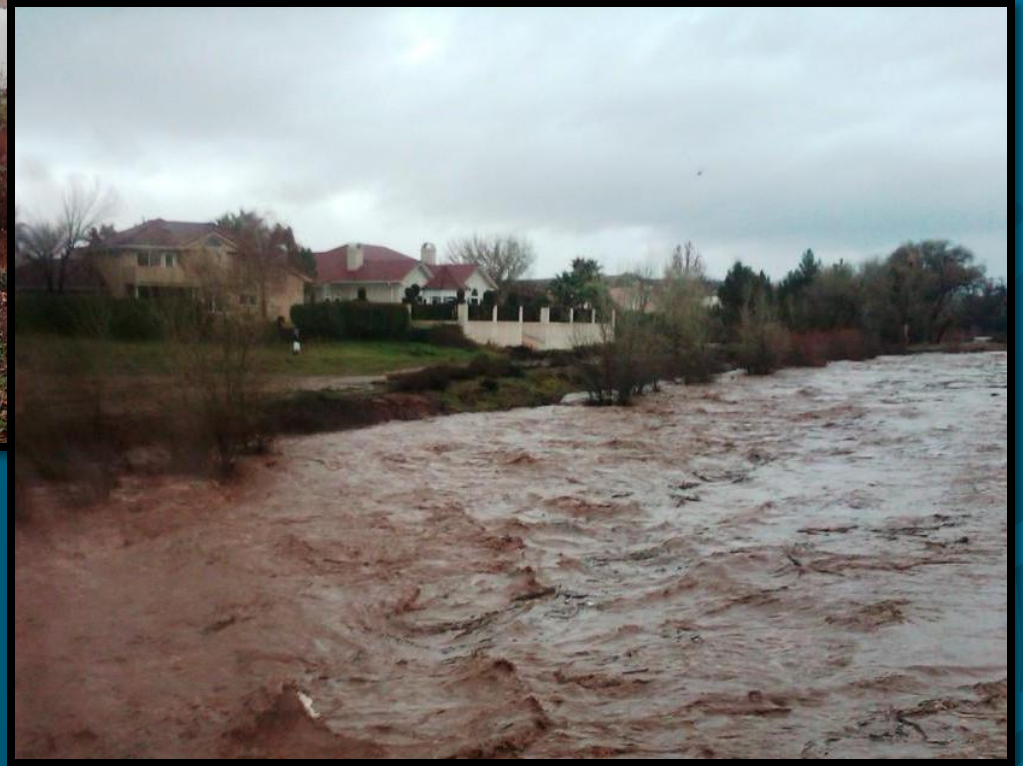
**Debris, Sediment
Alter flows**

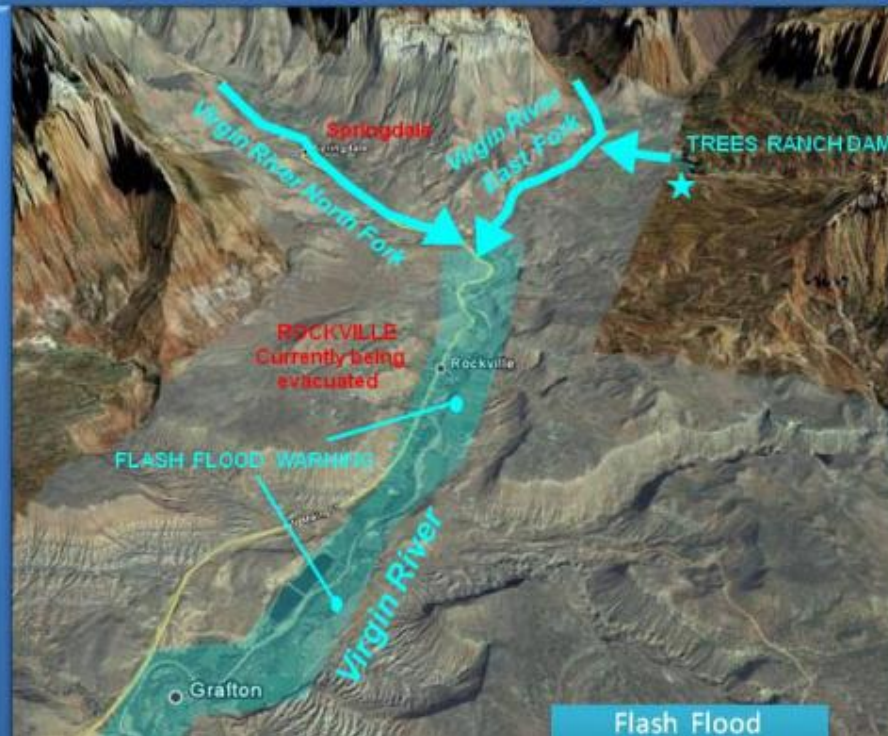
Worst Case Scenario of Flash Flood on the Virgin River

Flash Flood
Warning: In effect
for the east fork of
the Virgin River in
Washington County.
Failure of the Trees
Ranch Dam is
possible.

Flow from dam will
enter the East Fork
of the Virgin River
and then merge
with the North Fork
of the Virgin River
east of Rockville.

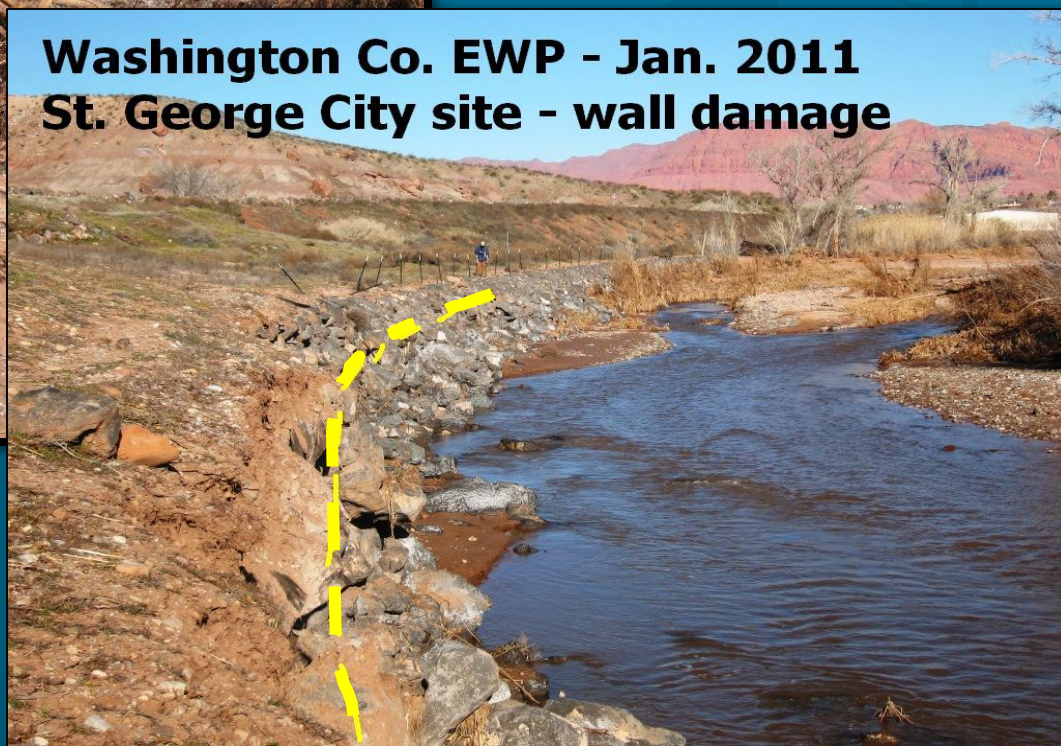
County well-prepared
Rock protection held

Minor damage to walls

Washington Co. EWP - Jan. 2011 St. George City site - wall damage

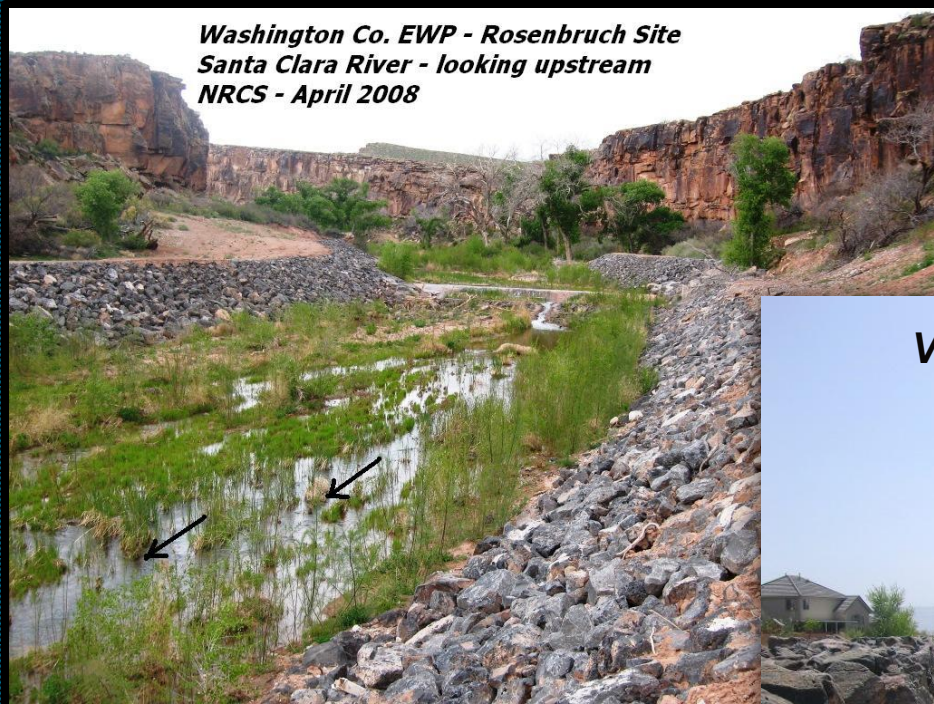
*Washington Co. EWP - Rosenbruch Site
Santa Clara River - looking upstream
NRCS - April 2008*

Willows returned the following season after construction

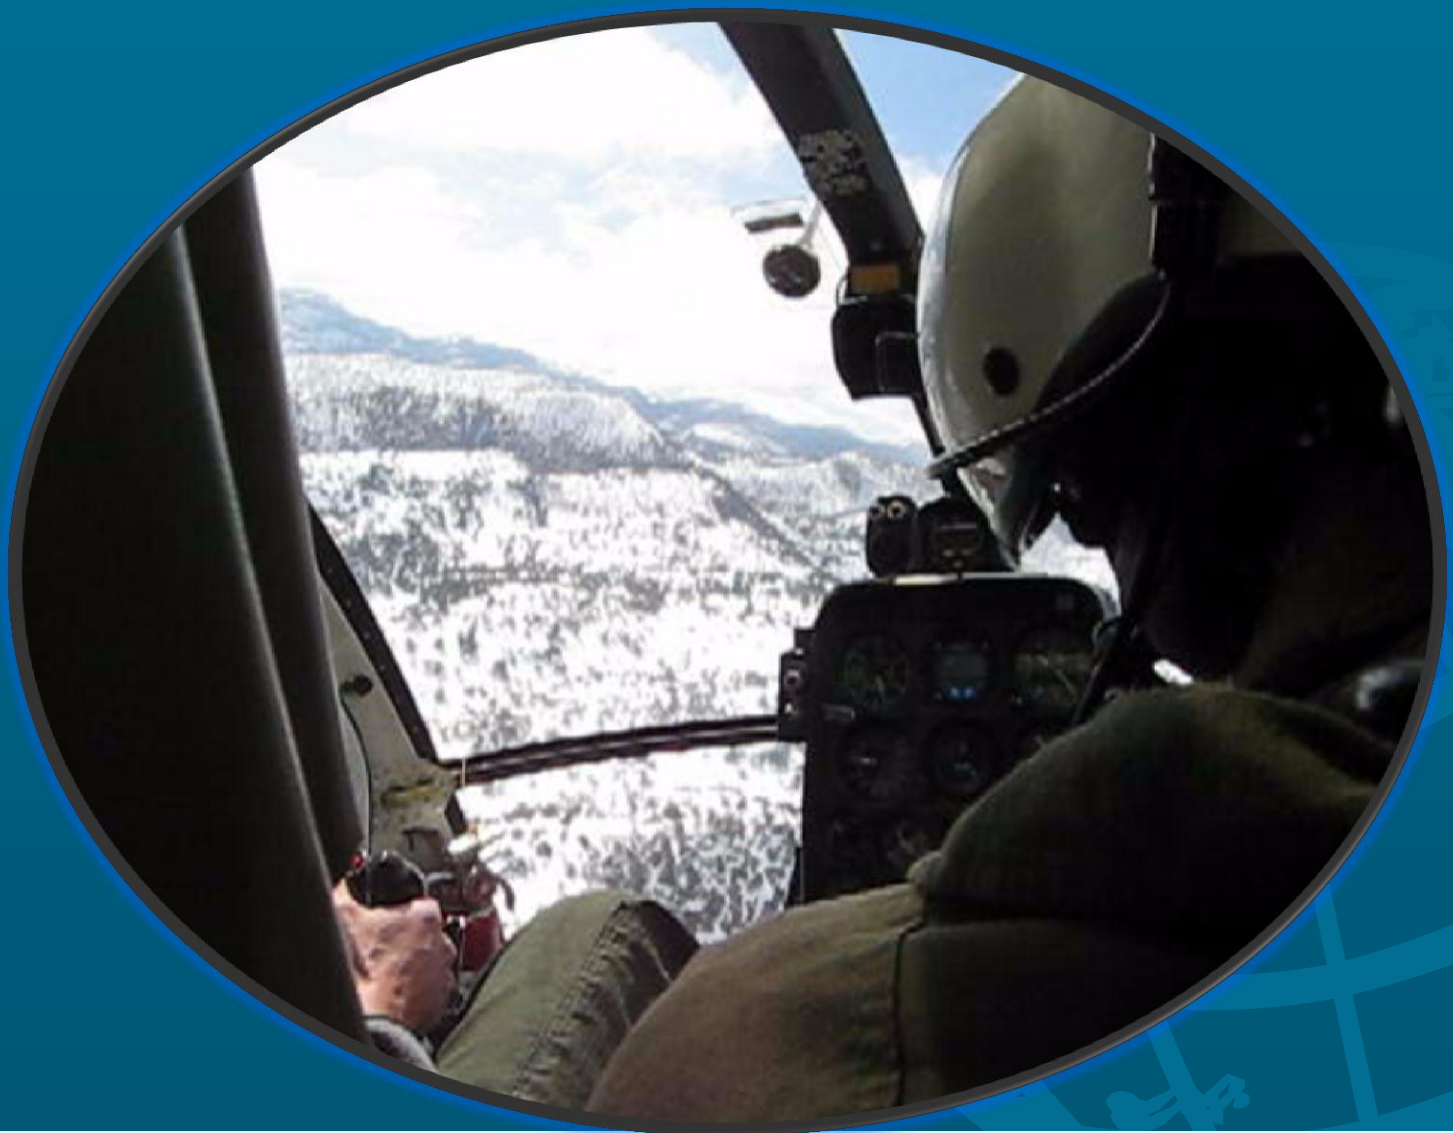
**Record
Snowpack
on burned
slopes**

**Special
study to
determine
hazard for
upcoming
melt**

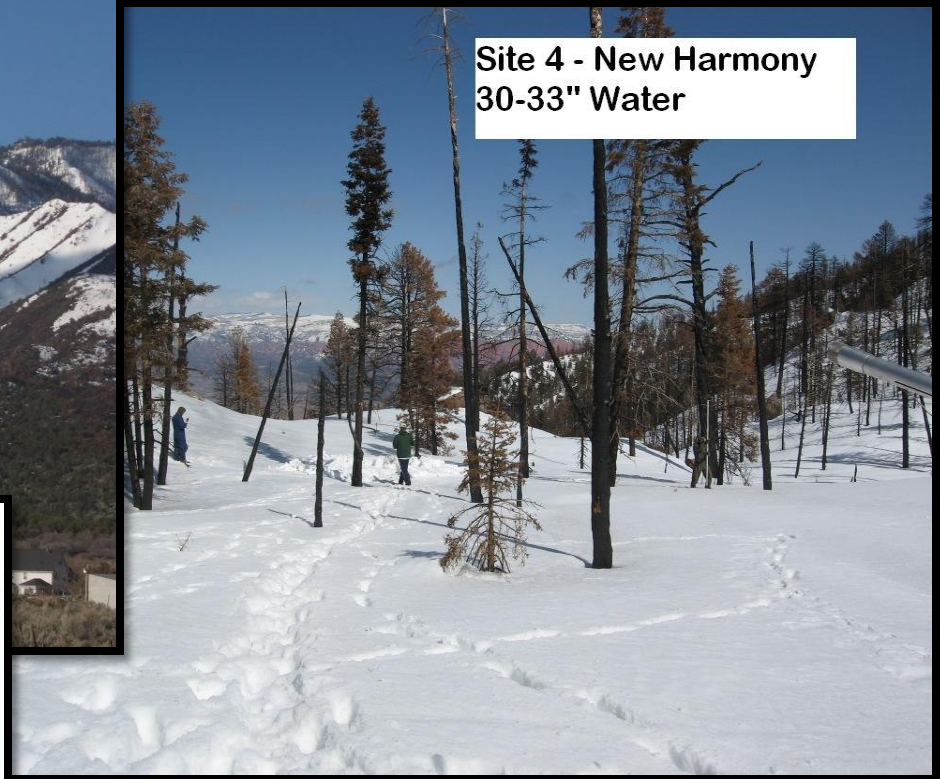
Site 4 - New Harmony
30-33" Water

Soil tests = good capacity for
infiltration = lower risk for
snowmelt debris flow

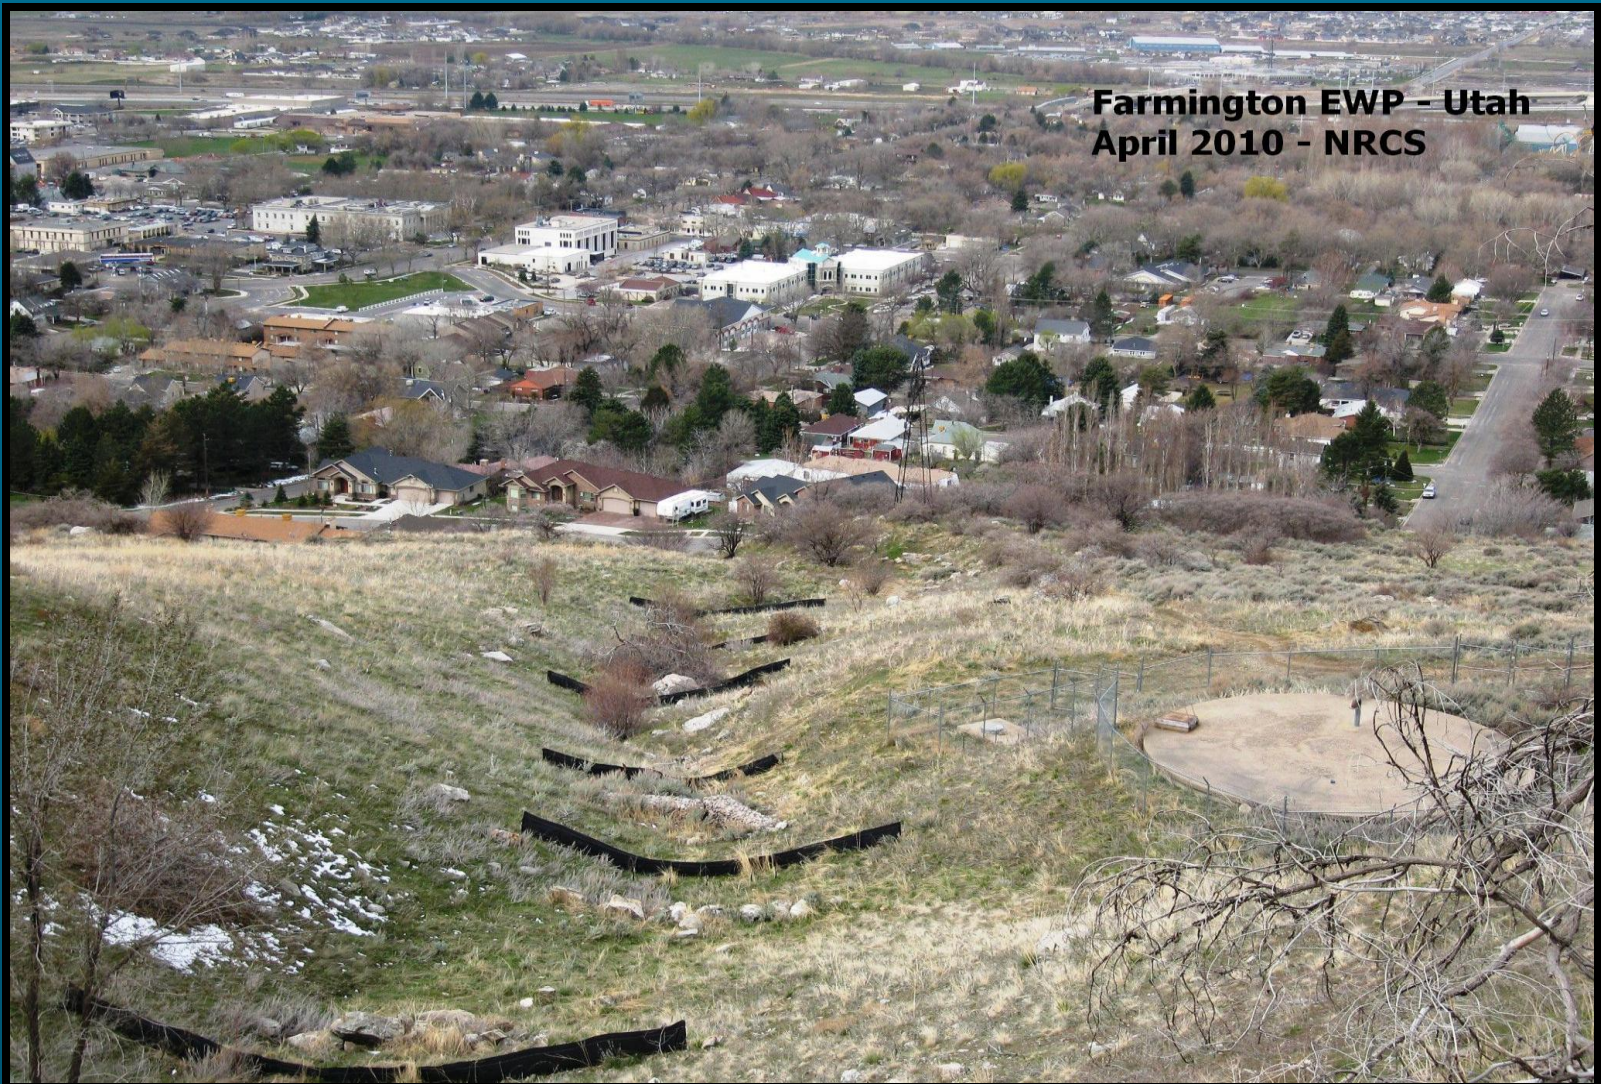
Sheet-Rill
Erosion
Protection

Silt Fence
Practice

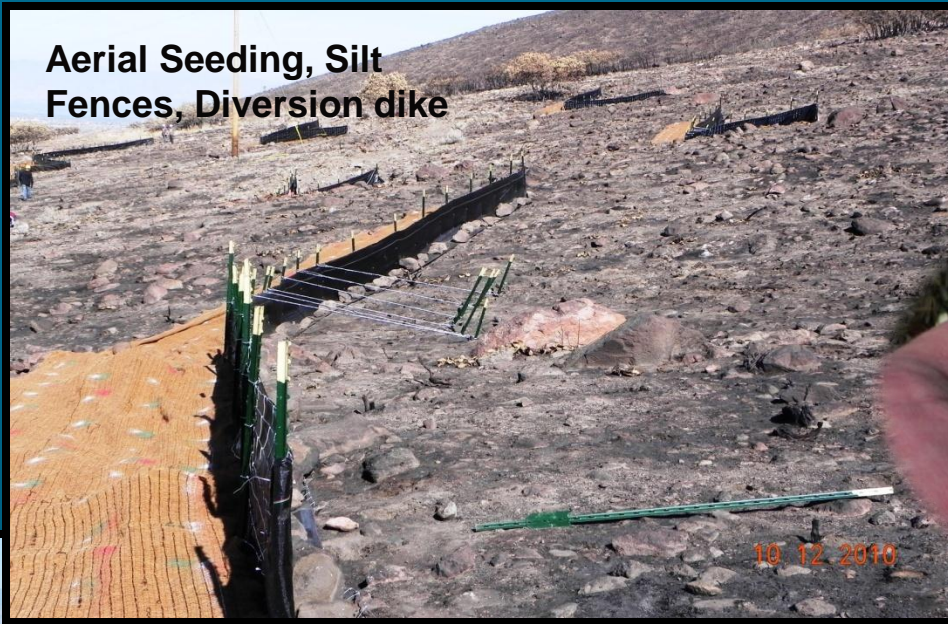
Aerial Seeding, Silt
Fences, Diversion dike

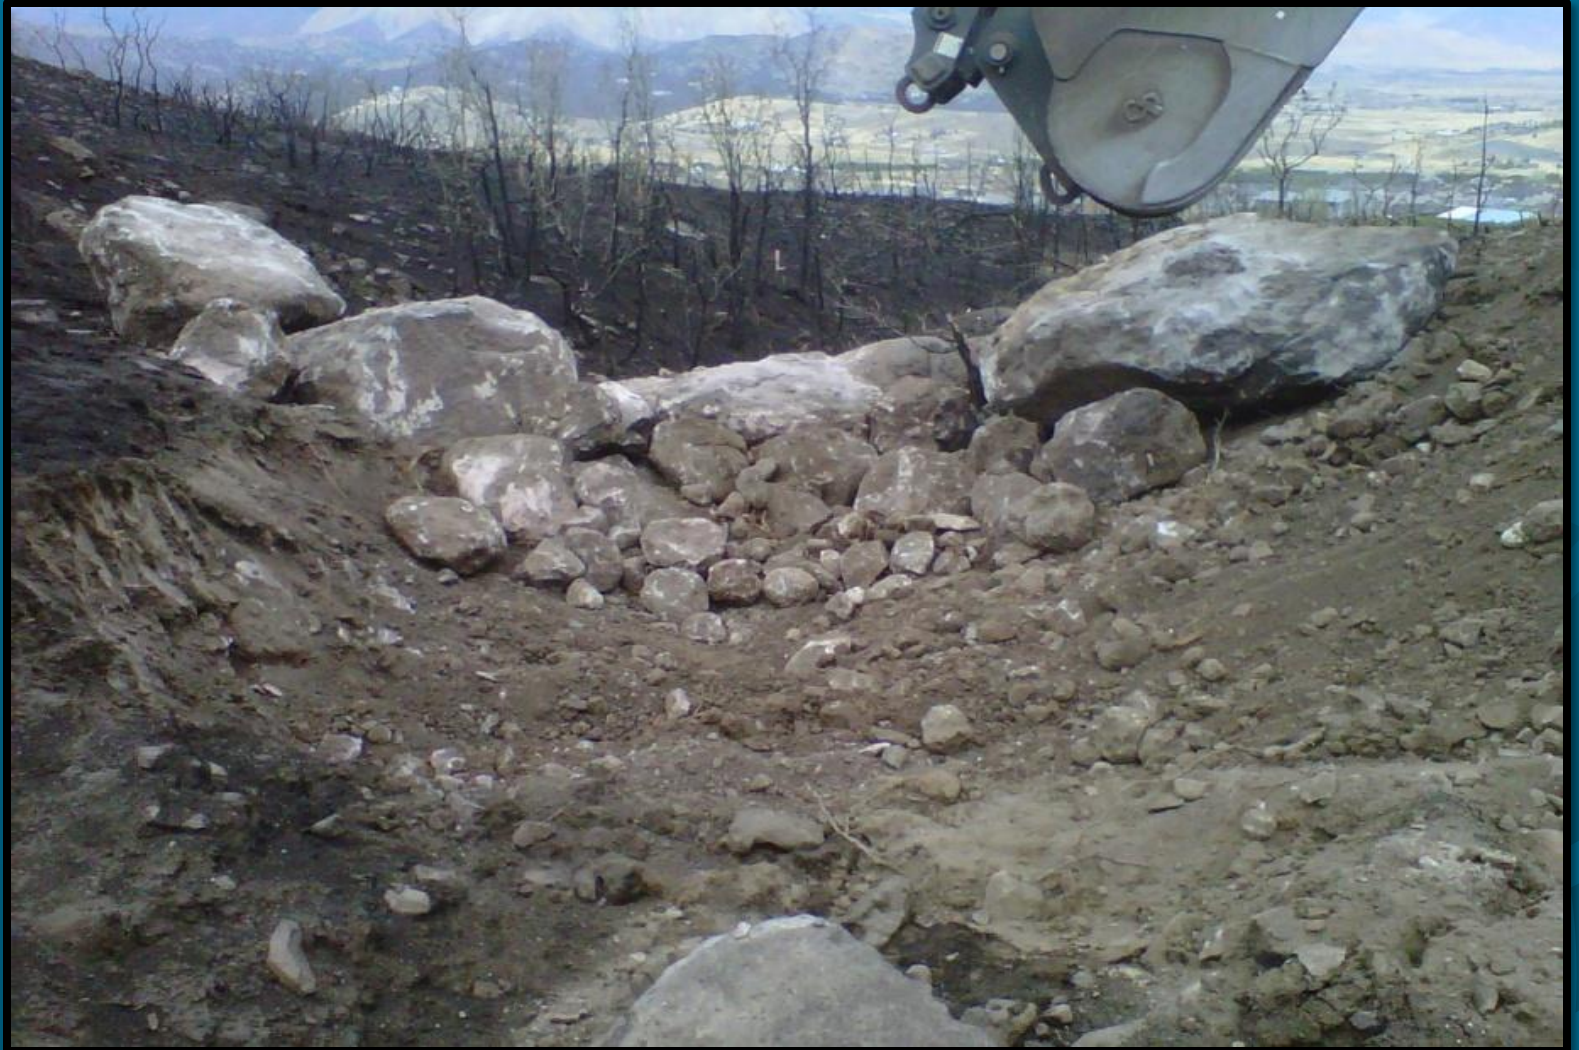
Rock
check
dam

Rock
from
adjacent
slopes
